**Motorola DTR600/700/720 series two-way radio**

**Firmware Update info**

**6-July-2020**

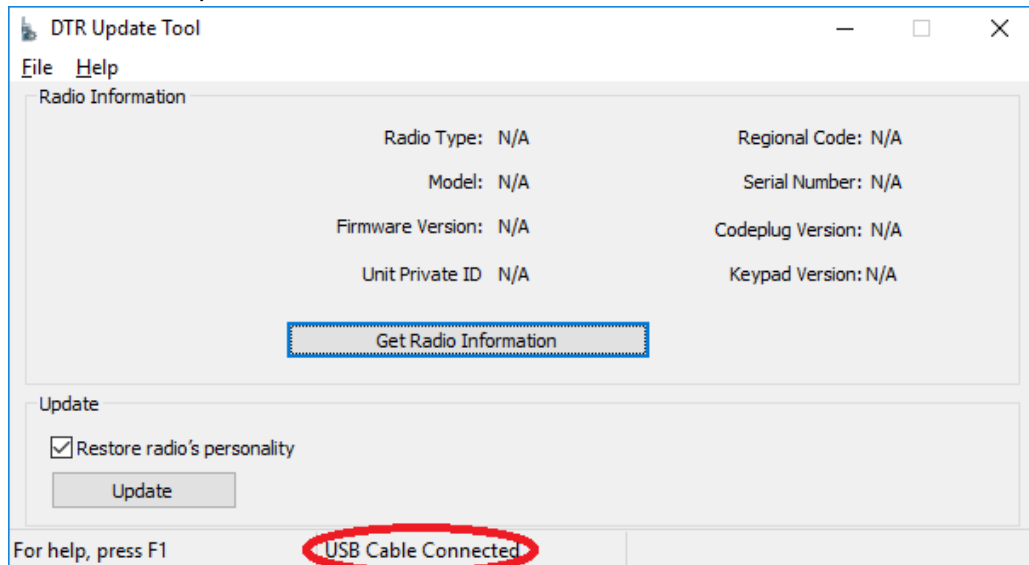
1. Before starting, ensure no other USB devices are plugged into your computer except keyboard and mouse.
2. Execute/Run the Update Tool program with computer connected to radios via cable and docking station, please wait for a while, you should see “USB Cable Connected” at the bottom of the Update Tool.

3. If you do not see “USB Cable Connected”, please check if your computer has successfully installed the programming cable driver.
4. **Ensure the battery is full** and inserted into the radio then turned ON the radio. Put the radio onto docking/programming/charging station.

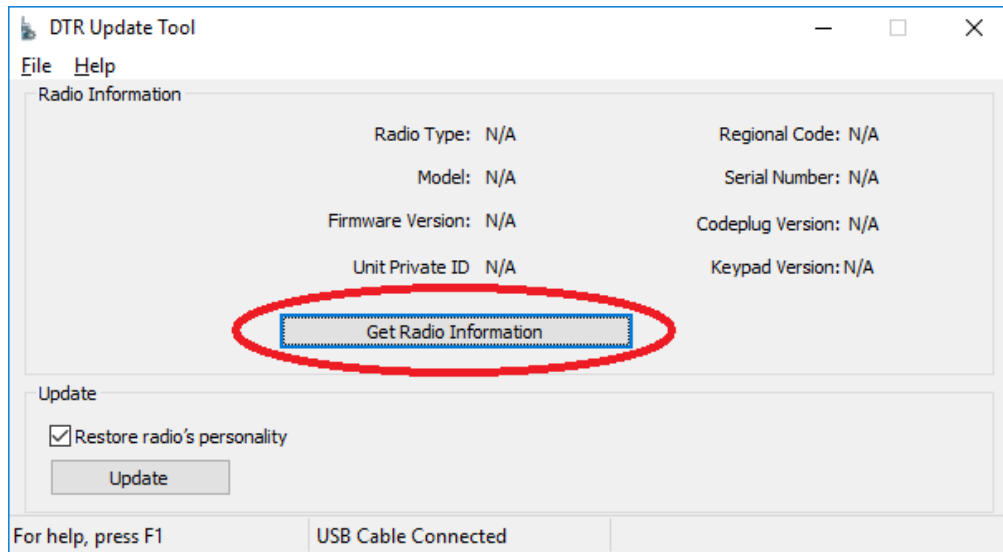
- Click “Get Radio Information” button to read the current radio information and show on the screen.

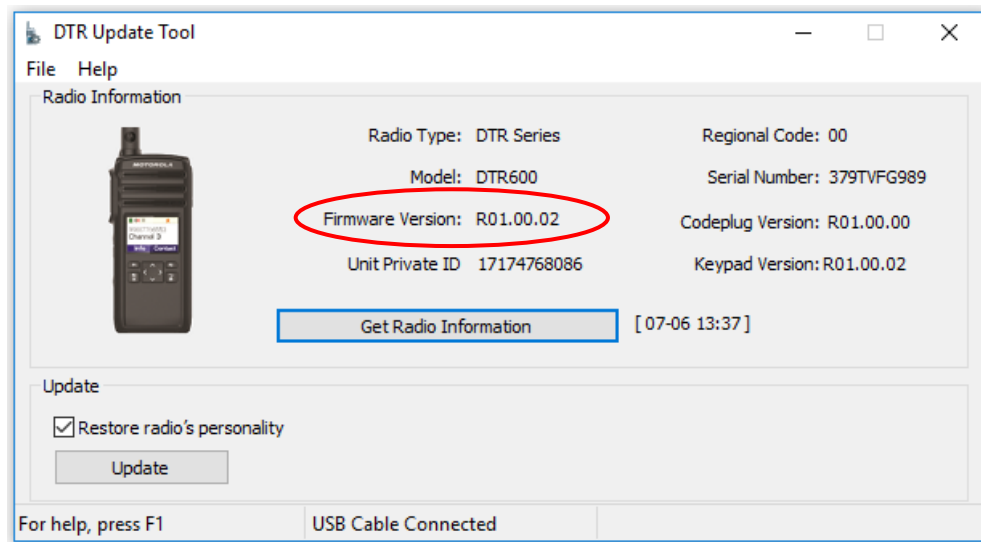
7. Ensure the radio model is the one you want to upgrade and with correct firmware version which is R01.00.02 in this example. Do not proceed update if the radio is not the correct model/firmware version.

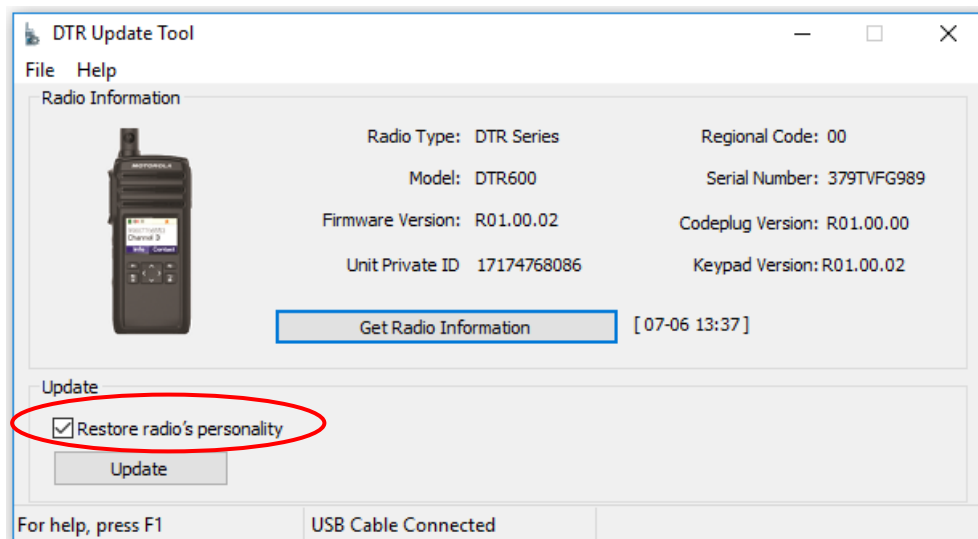
8. Select "Restore radio's personality" if you need to restore your previous configurations.  
\*\*\* if "Restore radio's personality" is selected when upgrading DTR600 from older FW version to R01.02.02, "Enable Profile ID Pin" setting will be restored too. To change "Enable Profile ID Pin" setting from disable/unchecked to enable/checked, user can only change via CPS if need to restore previous configuration OR unselect "Restore radio's personality" to factory reset radio configurations when upgrading FW to R01.02.02.

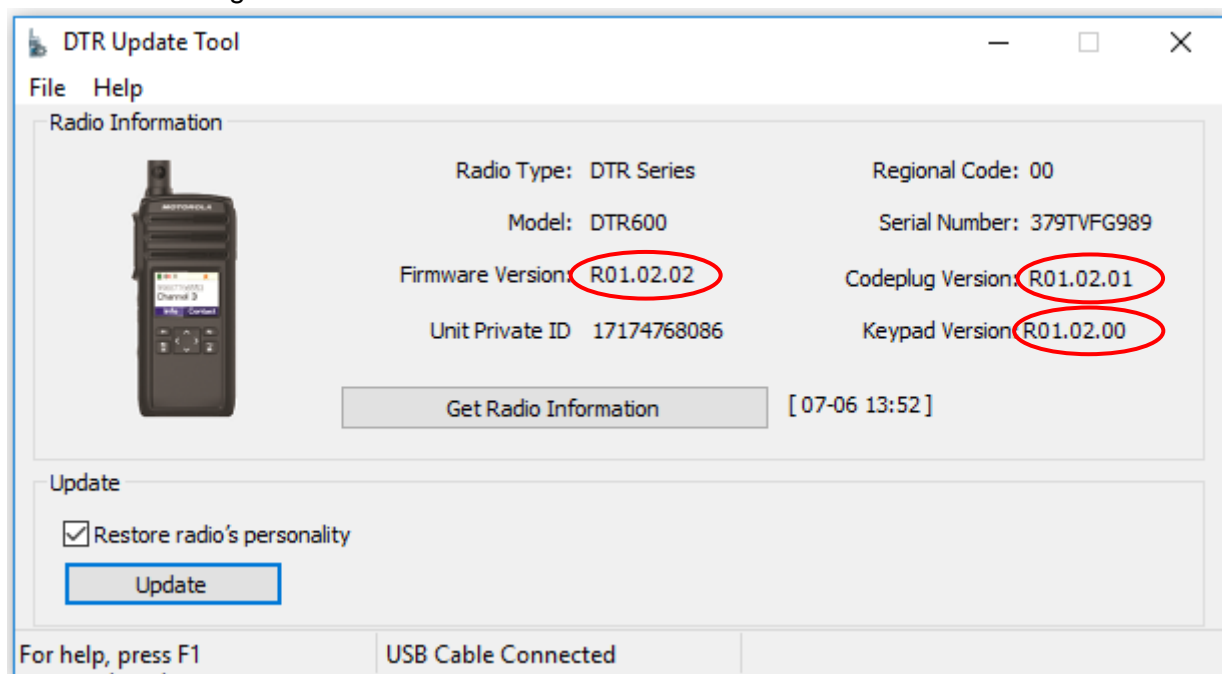
16. Check the Radio Information in DTR update Tool and make sure all firmwares version are the same as figure below.
